Report No. MCR-74-88  
NAS9-13570  
DRL T-914, Item 2  
DRD MA-378T

DISSIMILAR METALS JOINT EVALUATION  
FINAL REPORT  
APRIL, 1974

PROPULSION ENGINEERING, RESEARCH & DEVELOPMENT  
MARTIN MARIETTA CORPORATION  
P.O. BOX 179, DENVER, COLORADO 80201

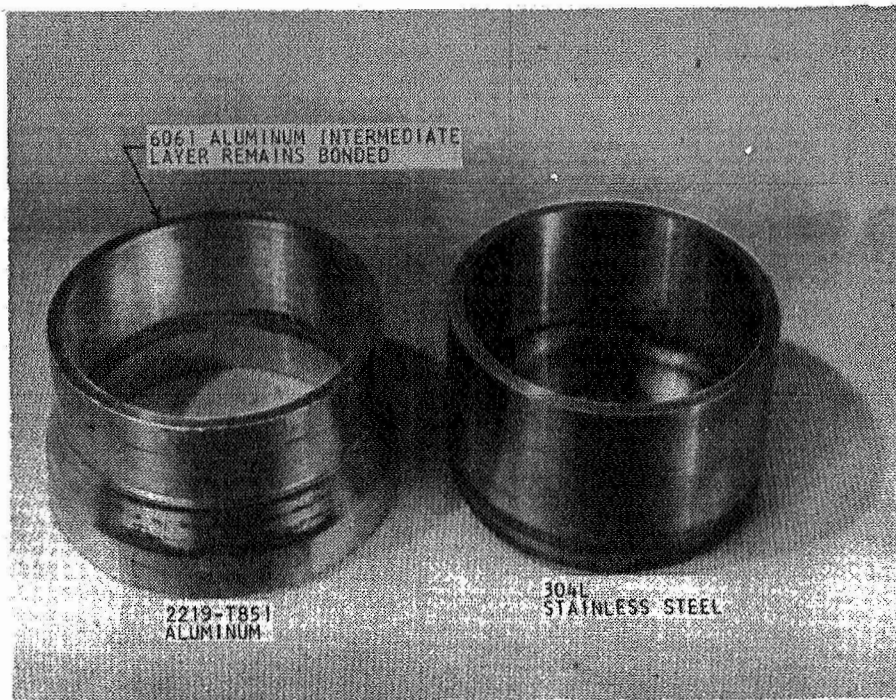
Figure 43. - Inertia Welded Joint Burst Failure

Figure 43 shows an inertia welded joint after burst. There was no apparent "necking" of the aluminum and very little residual aluminum remained on the stainless portion. This apparent "brittle" behavior of the bond at the 304L/6061 interface was evident on all inertia welded joints subjected to burst, and none of the joints showed separation of the 6061/2219 aluminum interface. Even though the bond appeared to fail in a "brittle" manner, the strength level and consistency of these joints was excellent.

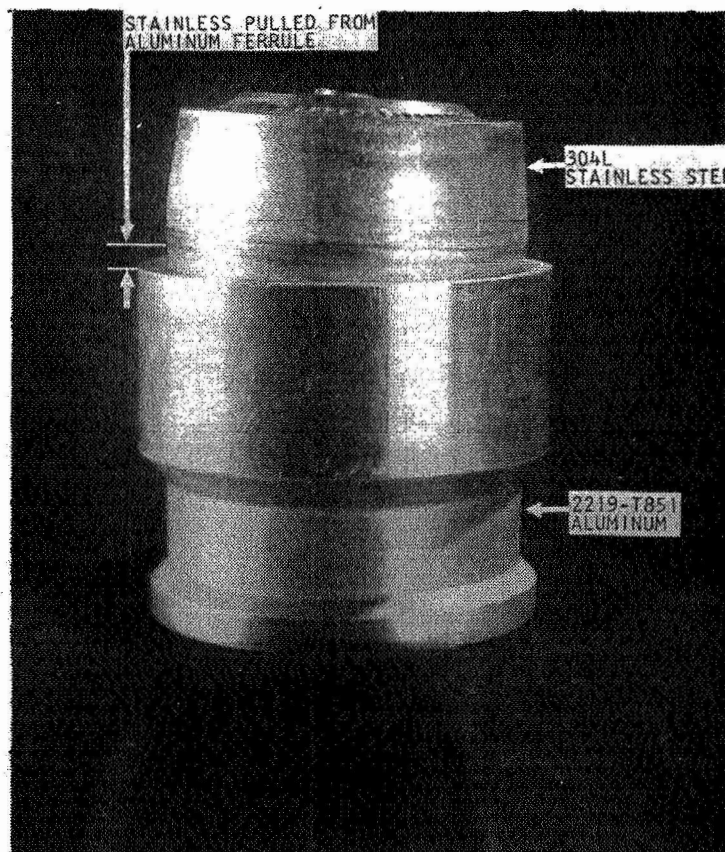
Figure 44. - Swaged Construction Joint Burst Failure

Figure 44 shows a typical hydroburst failure of a swaged construction joint. The stainless end slipped axially from the aluminum to a degree sufficient to allow leakage. One joint failed in a manner different from that shown in Figure 44; the stainless portion failed in axial shear where its sectional area had been thinned for the swaging process, and is shown in Figure 45.
